# Advanced Engineering Report : AER477A

## Sluice Gate - 2000 series

Customer Name: New Jersey Water Supply Authority  
 Address: South Bound Brook Lock  
 City, State: South Bound Brook, New Jersey  
 Zip Code: 08880  
 Dive Job Reference No.: 13681  
 Inspection Date & Gate No.: March 22<sup>nd</sup>, 2022  
Gate # 1 or "Roadside"

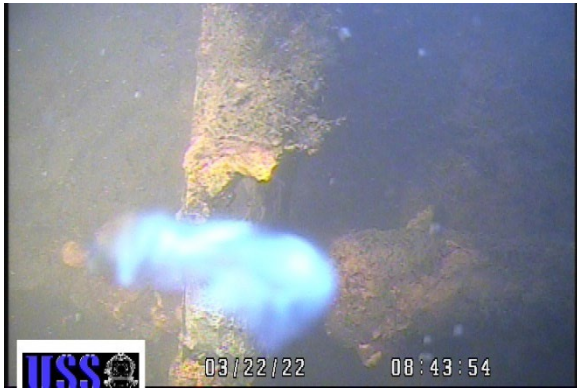
Stem

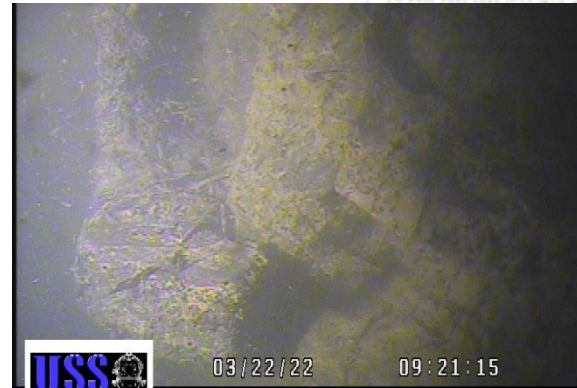
2	2002	Top Adjustment Wedges	Cast Bronze	R/A	
4	2003	LH Adjustment Wedges	Cast Bronze	R/A	
4	2641	RH Adjustment Wedges	Cast Bronze	R	Top wedge is misaligned & middle two wedges broke off
2	2040	Bottom Adjustment Wedges	Cast Bronze	R/A	
1		Bronze Thrust Nut	Cast Bronze	R/A	
1		Thrust Nut Bolt		R/A

<b>Notes</b>
9.2	<i>The overall condition is fair to poor; the gate wedges (on the right side) are misaligned or have broken off and are missing. Adjustment of this gate is not possible currently due to the missing wedges. The guide portion of the wedge assembly (located in the disc guide frame) must also be replaced; this will mean the bolts/anchors holding the frame and guides must be removed and the repair is typically done dry.</i>

Guide and wedge

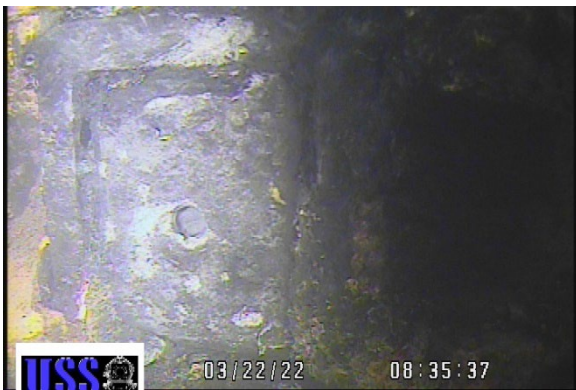
Thrust nut

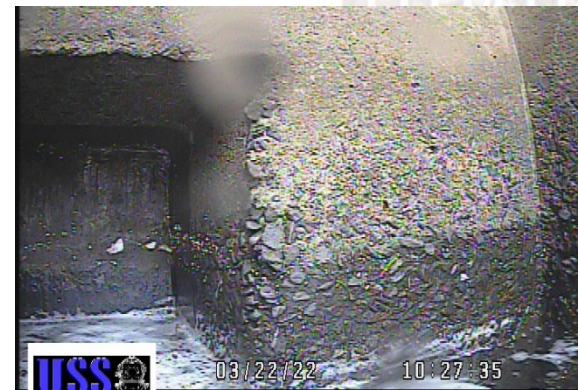
Condition of bulkhead downstream of gate
