NEW JERSEY WATER SUPPLY AUTHORITY

MANASQUAN RESERVOIR WATER SUPPLY SYSTEM

Technical Specification for Maintenance and Repairs to two (2) FMC model 45A 10'-00" x 18'-00" Traveling Water Screens for Manasquan River Intake

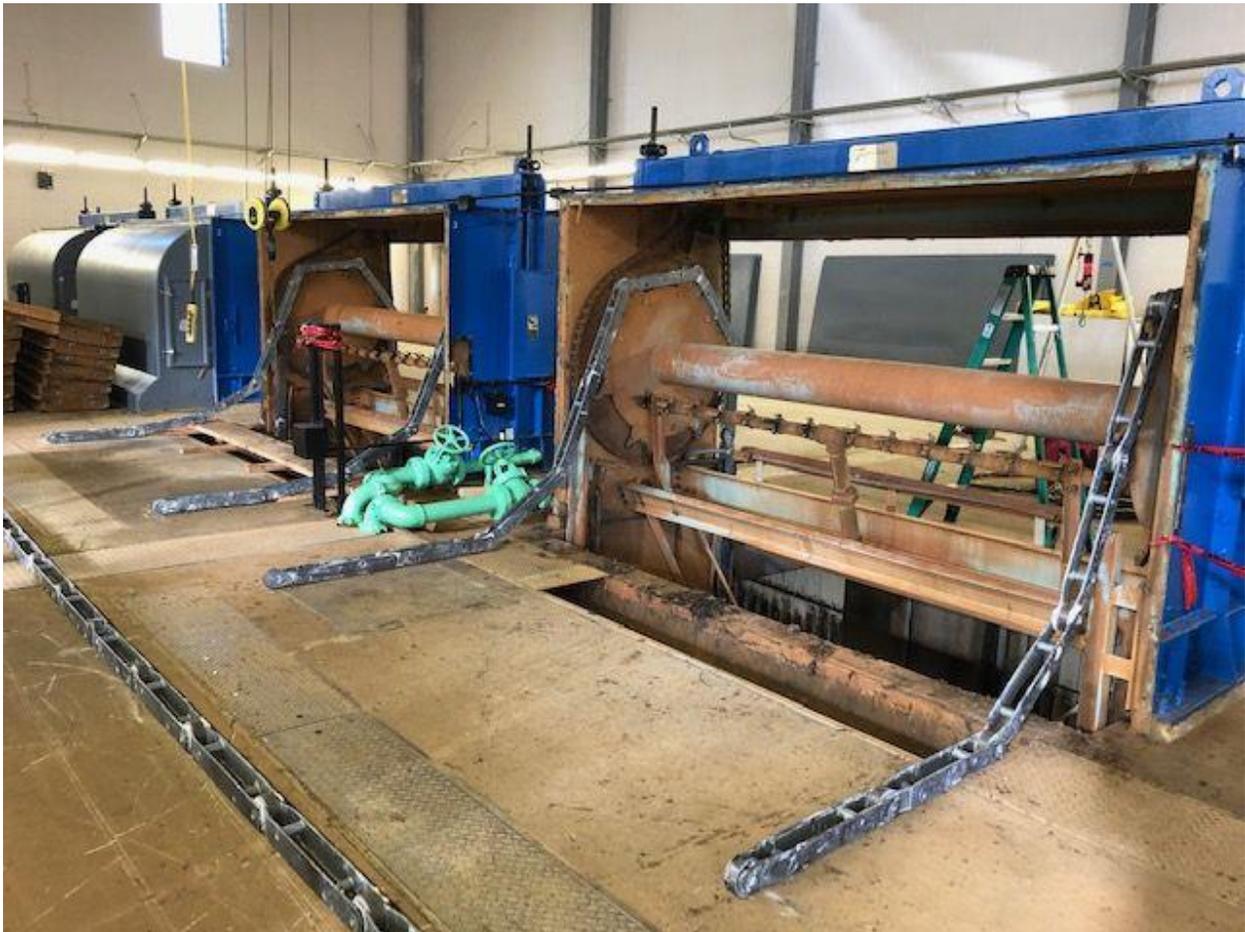
Work Area:

This work will occur in the Manasquan River intake pump building located at 2061 Hospital Road, Allenwood, NJ 08720. Within the intake building, there are eight traveling water screens that rest on a concrete floor slab which extends to the river's edge. 16.5 feet above this floor slab is the intake building's upper floor, where the water screen drives and covers are located. There is wall ladder access to the bottom on both the front and back of each water screen. Beyond the water screens is the pump sump from which the intake pumps draw water. The wet well's concrete floor is 8.5 feet below the floor slab where the water screens rest.
